DASE # 2560-15

RE: Prospect Building Inspection

This preliminary report will address item 5, Drywall and plaster ceiling falling from the second floor and roof framing.

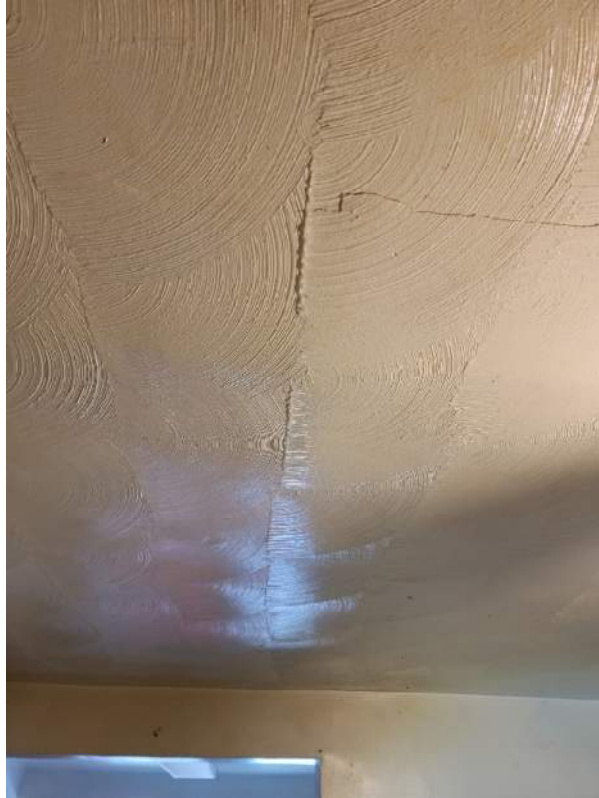
Typical ceiling crack in living room.

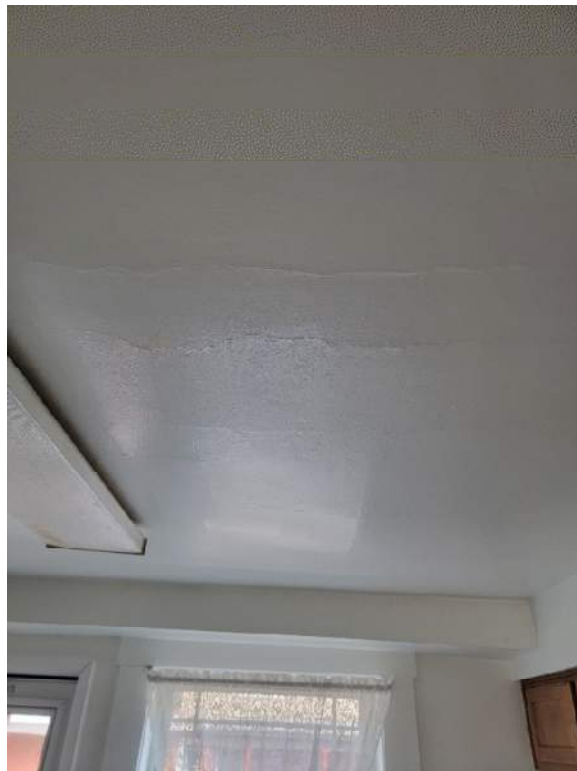
Typical ceiling crack in kitchen.

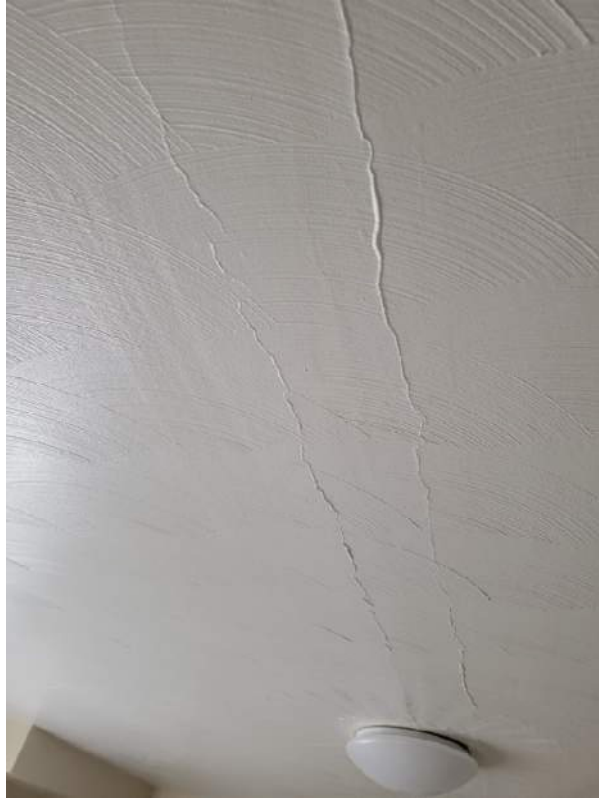
Typical ceiling crack in bedroom.

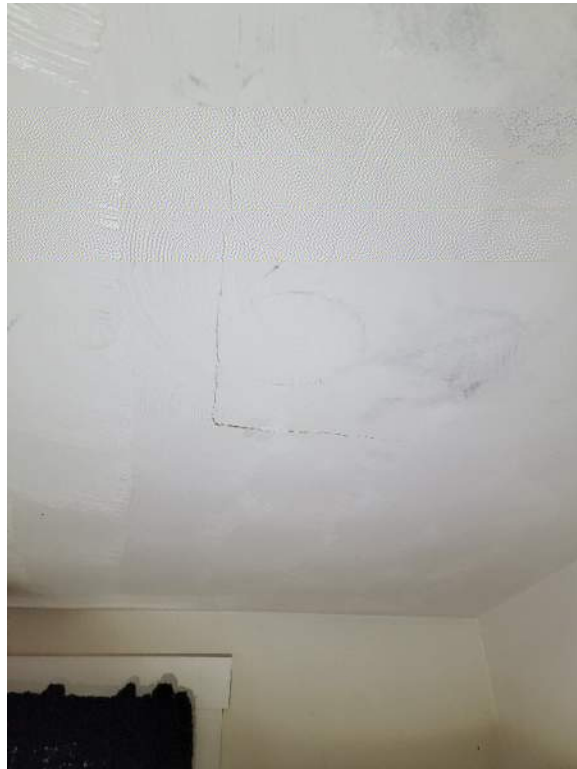
Typical ceiling crack in bedroom.

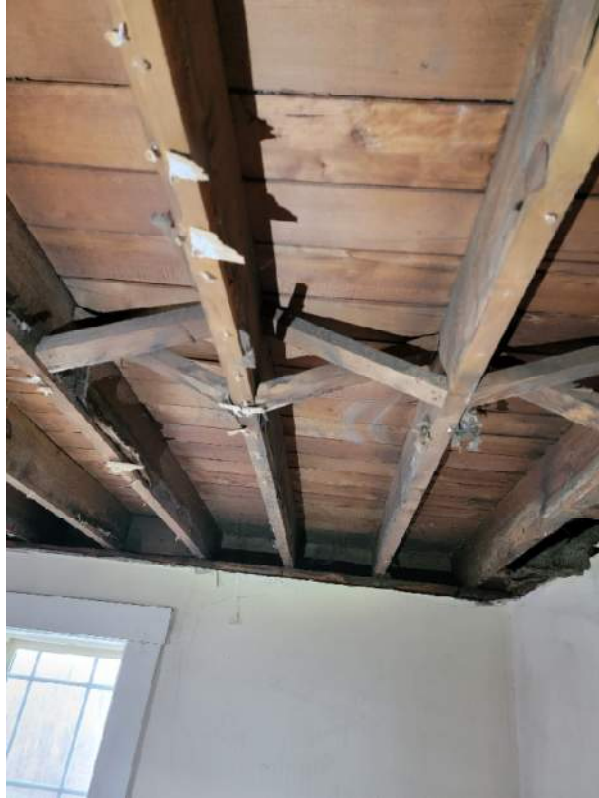
Joists showing nail pull over and nail withdrawal.

1. Remove the existing ceilings and install and finish new gypsum wall board using properly spaced fasteners such as dry wall screws and glue.
2. Install 1" x 3" wood lath strips spaced at 16" on center over the existing ceiling construction. Install and finish new gypsum wall board using properly spaced fasteners such as dry wall screws and glue. If this option is selected, the existing first and second floor ceiling framing should be analyzed to determine if the framing can support the additional loading.

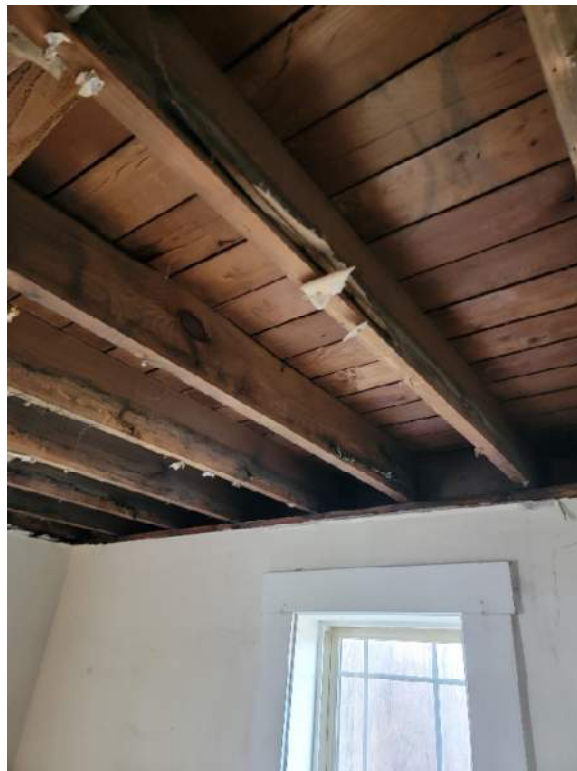
Joists showing nail pull over and nail withdrawal.
